EPA/OSHA JOINT CHEMICAL ACCIDENT INVESTIGATION REPORT

**Surpass Chemical Co., Inc.
Albany, NY**

Accident Investigation Report
Surpass Chemical Company, Inc., Albany, New York, April 8, 1997

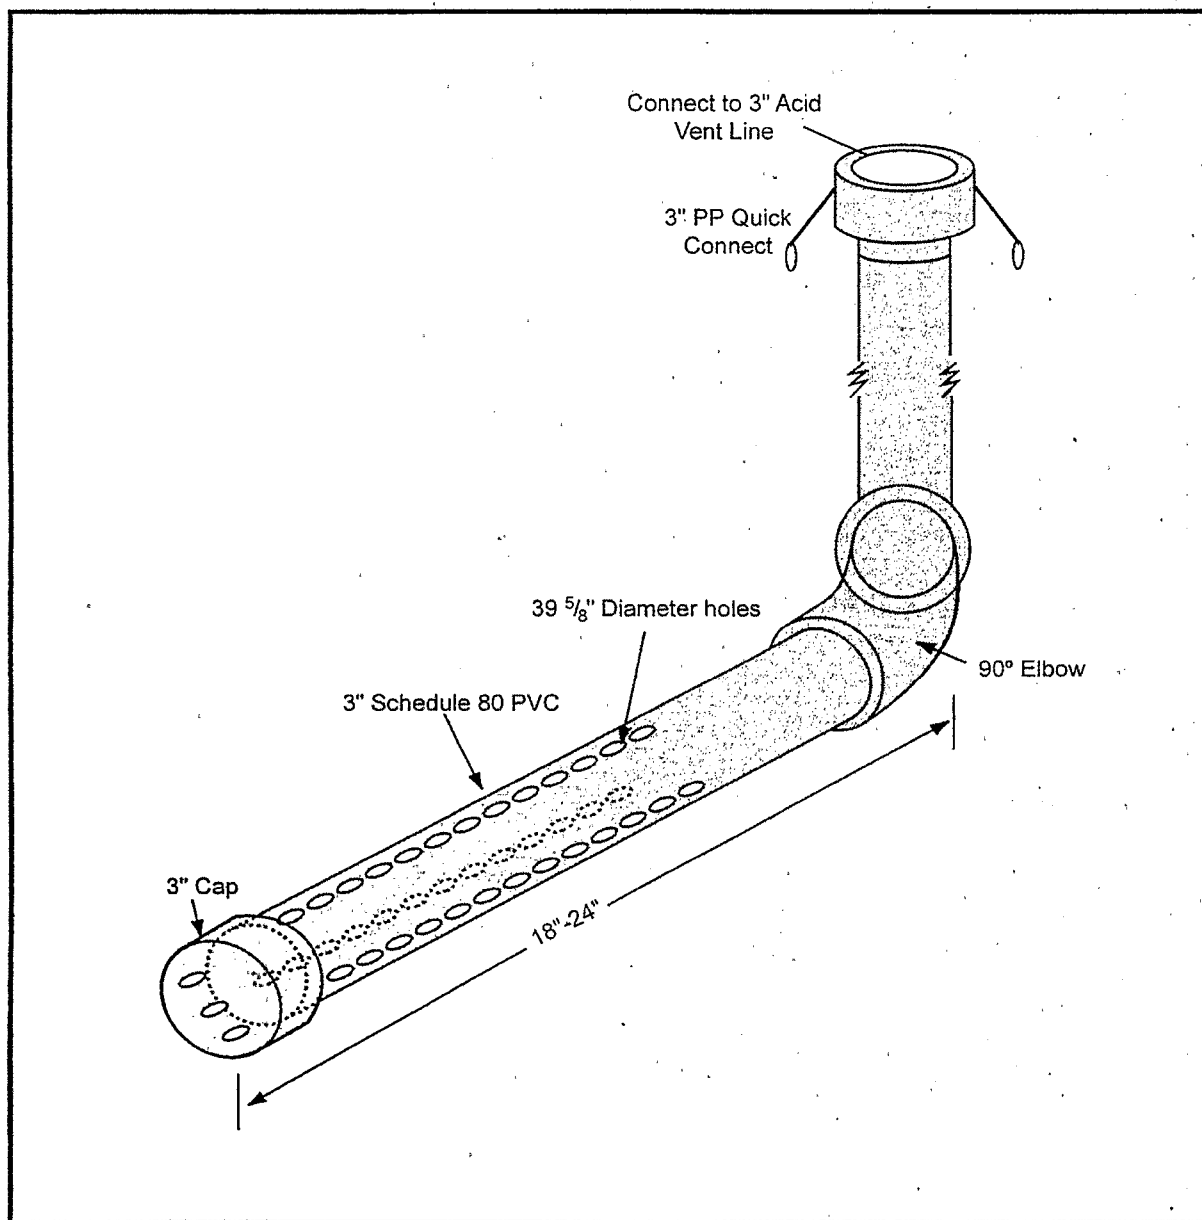
Figure 3: Diffuser Section of Vent System
(not to scale)

At the time of re-installation, Surpass made two additions to the HCl tank, a scrubber system and a pressure gauge adapted to indicate volume. The scrubber system was intended to reduce the quantity of HCl fumes escaping into the environment. Acid vapors generated during the filling operation were vented through two lines-- 2 and 3 inches in diameter-- that intersected at a tee and continued as a single 3-inch diameter vent line. This vent line ran from above the top of the tank and extended vertically below the HCl tank into a scrubber tank. (See **Figure 2** for a schematic of the HCl tank.) The end of the vent line was fitted with a diffuser section consisting of a connection, a 90° elbow, and an 18-inch length of 3-inch diameter plastic pipe which had been drilled with 36 holes, each 5/8-inch in diameter, and fitted with an end cap with 3 holes drilled into it (a total of 39 holes). (See **Figure 3** for a schematic of the diffuser section.)

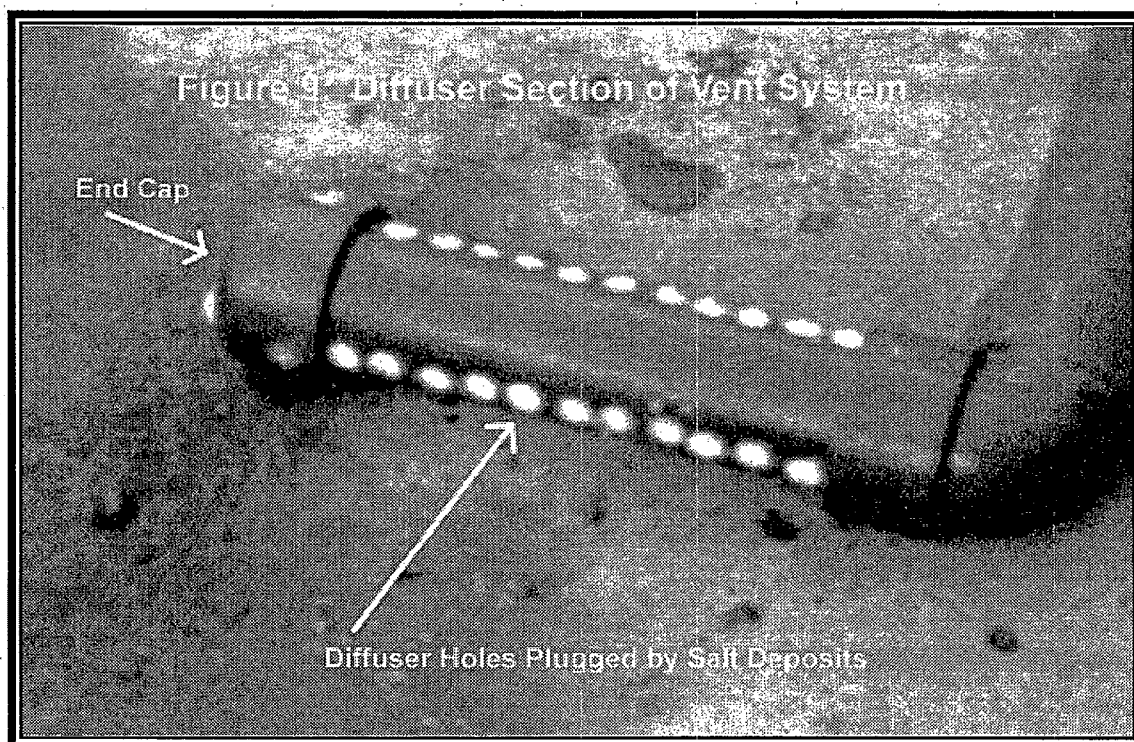
- The scrubber tank was not affected by the tank failure; it was found intact in its original position after the incident. (See **Figure 8**.)
 - After the incident, the diffuser in the scrubbing tank was removed by disconnecting the vent line quick connect and removing the lid from the scrubber tank. The holes in the diffuser were found to be clogged with a white crystalline substance, as shown in **Figure 9**. This substance was sodium chloride, according to laboratory analysis.

- A layer of white crystalline material was also found in the bottom of the scrubber tank. This substance also was sodium chloride, according to laboratory analysis.
